The Boone Dam Project

Tennessee Valley Authority (TVA) has completed a seven year US\$326M (£259M) project to remediate the Boone Dam in the US state of Tennessee

by Ettore Zanatta

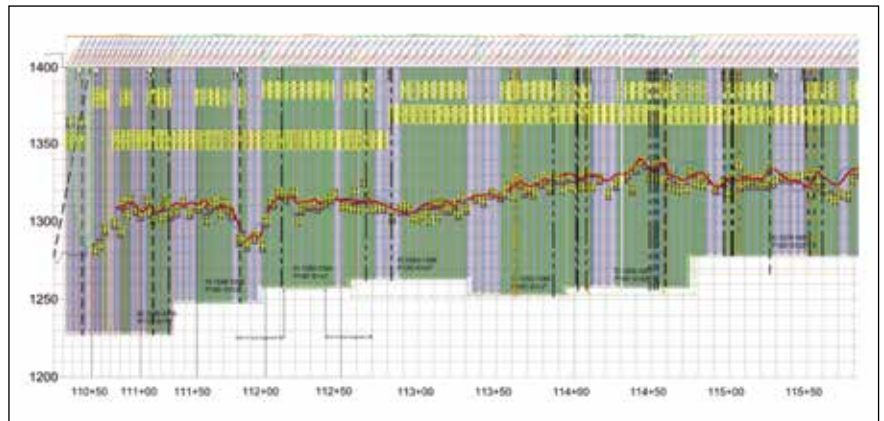
➤ Longitudinal section of the cutoff wall

After the completion of the preliminary enabling grouting works, in 2018 TNJV, a Joint Venture formed by Treviicos and Nicholson, was awarded the contract for the installation of the cutoff wall. With the working platform at approximately elevation 1,400 feet and the bottom elevation of the cutoff wall as low as 1,230 feet, the wall has a resulting maximum depth of approximately 170 feet, and is formed by a single row of secant

piles extending through embankment, foundation soils, and weathered rock into intact rock up to 170 feet below crest, including tie-in of wall on sloping face of existing concrete dam. The technology of the secant piles was chosen after consideration of a number of cutoff wall construction methods for having lower dam safety concerns, and to maintain strict alignment and overlap requirements while penetrating through a challenging mixture of soil and highly weathered rock within the upper portions of the dam's foundation. The cutoff is keyed into the sloping face of the existing concrete dam, forming a continuous composite seepage barrier could along the entire alignment of the earthen dam. Over 300 50-in dia. secant piles were installed to create 850-ft long secant pile barrier, totaling 113,000 square feet of cutoff wall, and 27,000 cubic yards of concrete for backfilling. Verification of the verticality, embedment and concrete quality of each element forming the wall was critical. The secant piles were installed using a combination of equipment and techniques: piling rigs were used to drill through the embankment and the alluvial, to depth of approximately 100 ft, using segmental casings. Reverse

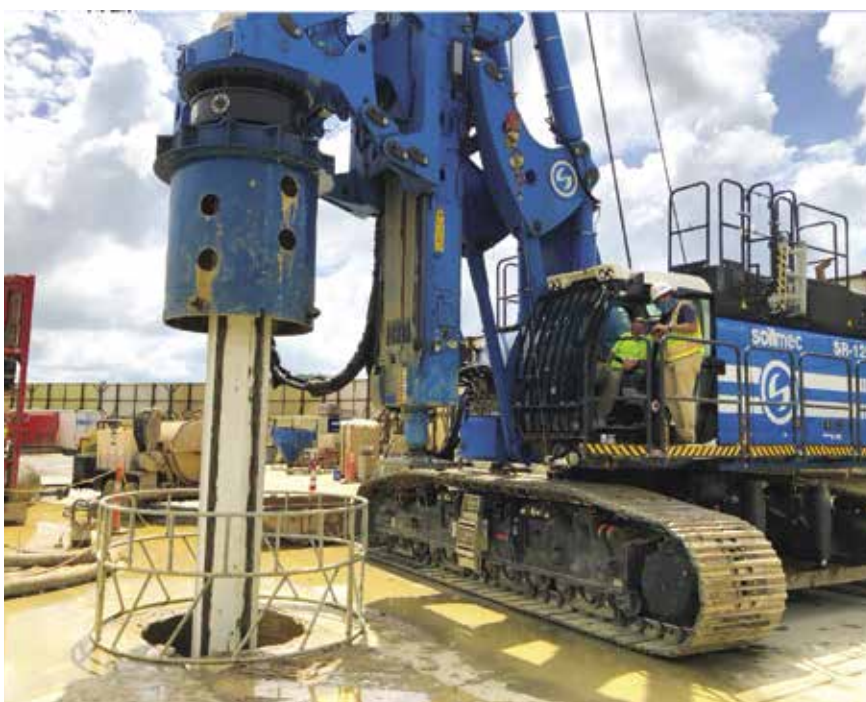
➤ A Soilmec SR-125 piling rig was used to drill into the embankment
Picture: <https://twitter.com/BooneRepair/status/1278710045535023107/photo/1>

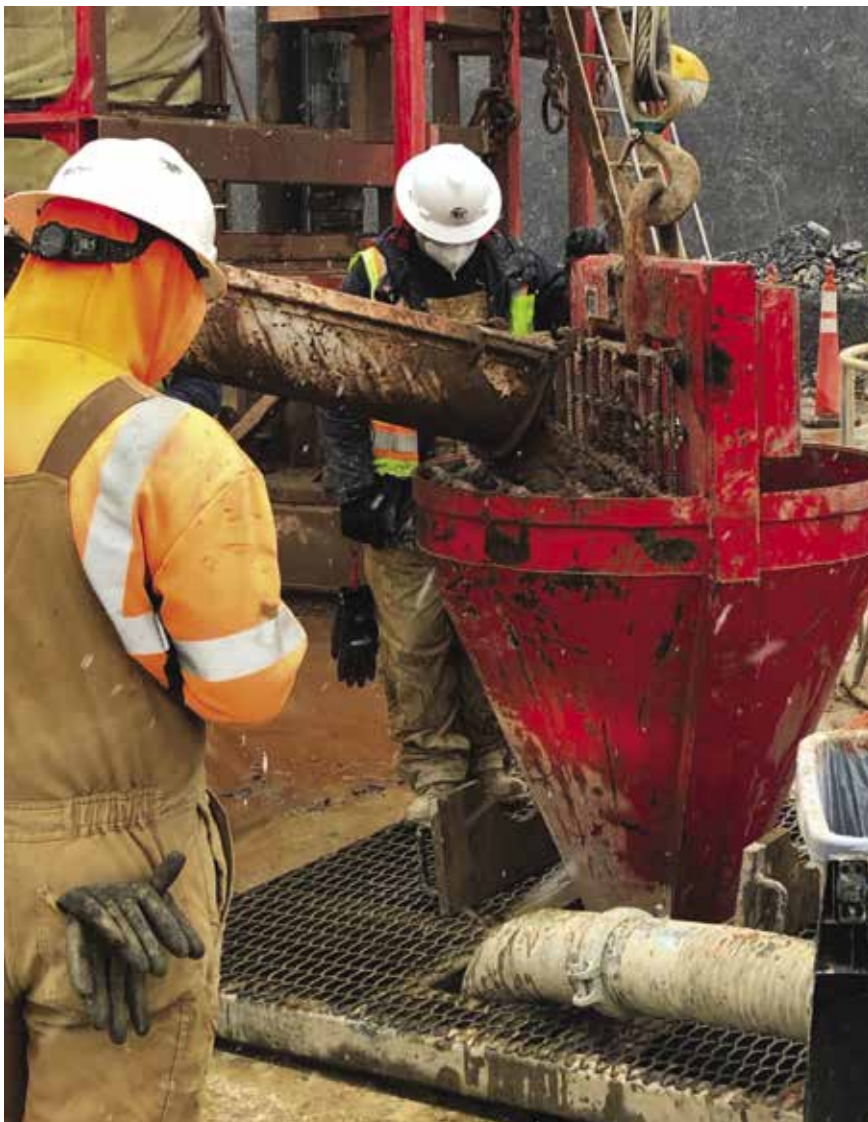
➤ Backfilling of a pile, using tremie concrete
Picture: <https://twitter.com/BooneRepair/status/1356619037627863045/photo/2>

circulation top pile rigs then completed every pile, to a total maximum depth of circa 170 feet, into a rock with peak UCS values as high as 36,000 psi (240 MPa). The concrete for the piles was manufactured in an onsite batch plant operated and controlled by TNJV. The quality of the joints between the elements was of paramount importance for the integrity of the wall. An extensive quality control program provided TVA with an accurate validation of the installed final product for their acceptance. This, in conjunction with an equally extensive quality assurance program, ensured that the cutoff wall was installed meeting or exceeding the stringent requirements of the Project. For instance, as part of this program, vertical deviation was checked by measuring with different instruments and piles were brushed to grant quality joints.
